**ANALYSIS OF SEISMIC RESPONSE AND REHABILITATION PROJECT  
FOR A MASONRY BUILDING SITE AMATRICE (RI),  
DAMAGED BY THE L'AQUILA EARTHQUAKE OF 06 APRIL 2009**

The article aims to provide a description of the seismic response of a masonry building located in Amatrice (in the province of Rieti, 33 km away from the epicentral area) and damaged by mainshock and aftershocks, as well as a project for the restoration of seismic safety compromised due to the substantial damage on masonry load-bearing structures and secondary structural elements.

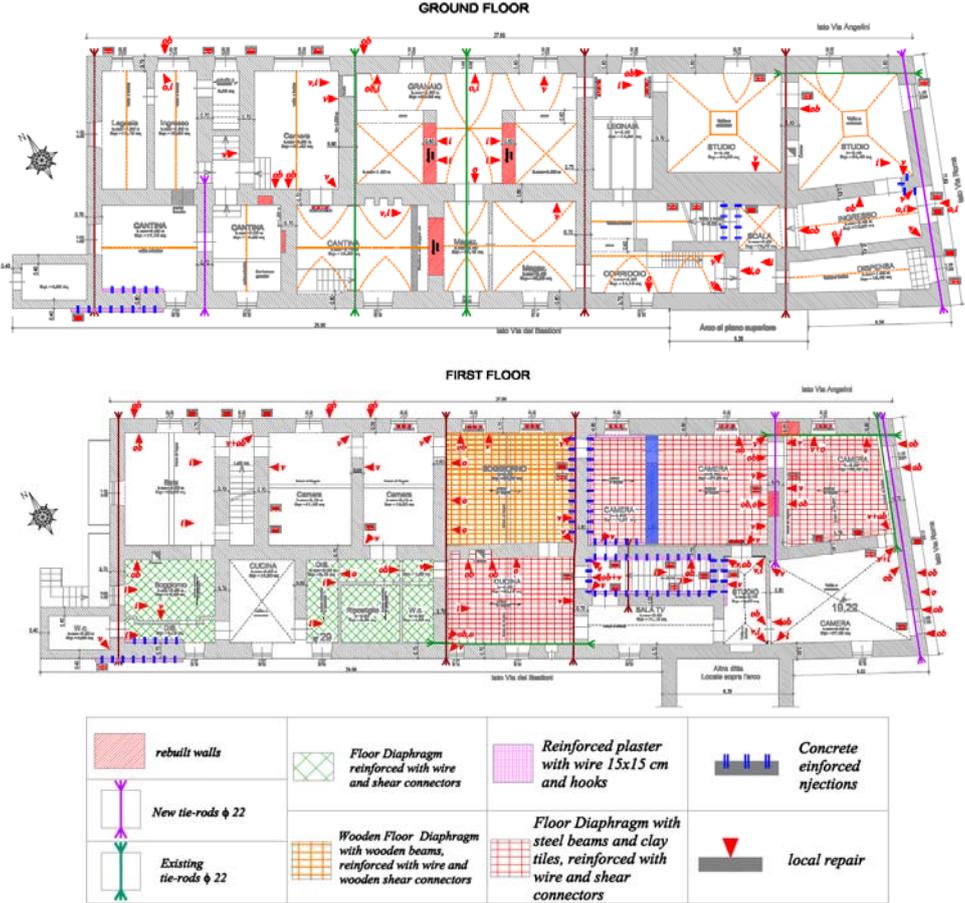
Figure 5: plans of interventions on the building,

Structural interventions, set out in the seismic rehabilitation project (see Figure 5), aiming at seismic vulnerability reduction, have as their main objective the preservation of materials and original resistance structural mechanism, as long as it does not cause early collapse of the building. Moreover their choice must depend on results of the evaluation phase. In particular, interventions will have to reach the safety and durability of the building producing the minimum impact on it and respecting, if possible, both the original structural configuration and all subsequent modifications. From this point of view, damaged structural elements must be repaired as long as possible while element substitution and utilization of innovative systems should be avoided, unless their compatibility with original materials was demonstrated. Finally, particular attention was given to an executive phase of interventions in

on north and east sides. In the second phase a new structural model was created in which several structural elements were designed in order to avoid local collapse mechanisms. This new model, identified with FM-1 code, has highlighted the good effect of interventions: local mechanism activation was avoided and the seismic safety index related to SDLS has passed from 0,83 to 1,22 with an increase of over 45%. This proves that provided interventions, blocking the activation of the local mechanisms, had a beneficial effect also on the whole building behavior. This phase of the study is aimed to carry out analysis to evaluate seismic behavior of the building after interventions. Due to building degradation, the substitution of the existing covering floor with reinforced concrete riddles and a wood floor having a good connectivity to the wall was provided.
